# Manhole Inspection Summary

Manhole # S07GG2028MH

Insp Date: **9/9/08 11:20 AM**

**Location** Address: **2701 HANSON**

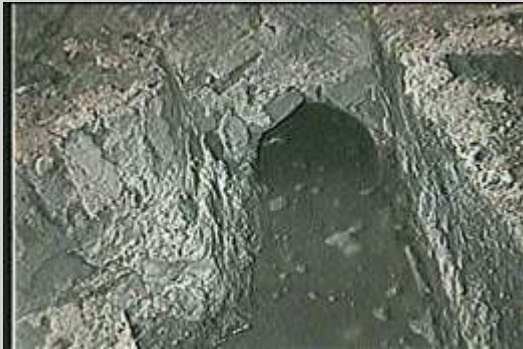
### 8 in. Circular Gravity Sewer Pipe Out @ 12 O'Clock

Rod and Bar (Angled)

Pipe Material: **Clay** ☐ Pipe Lined

Infiltration: **None** Pipe Seal Cond: **Unknown**
